SOUTH SIDE SLOPES

Public Staircase Inspection

Baker

July 2008

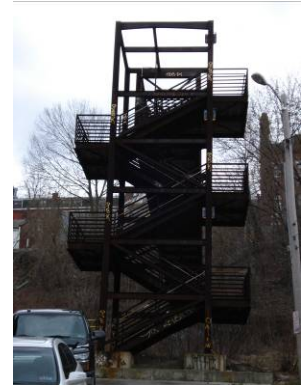
Staircase One

Surface Cracking at Handrail Base

The first section of the staircase has mild spalling and rust staining from the surrounding COR-TEN steel structure. The second section of the staircase also contains rust staining on the surface of the bridge from both the COR-TEN steel structure and the chain link fence surrounding the bridge. The third section of the staircase contains some cracking, mainly on the surface of the steps at the base of the handrail.

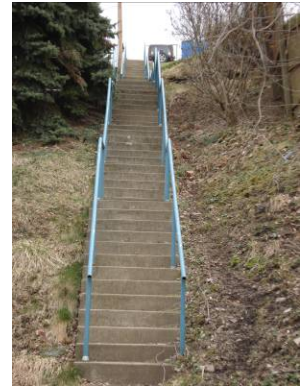
Spalling

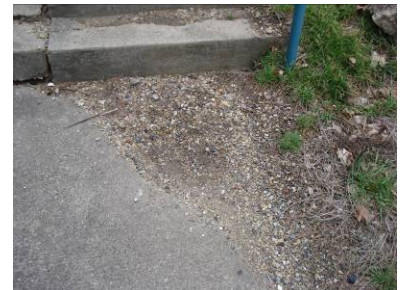
Runoff Debris

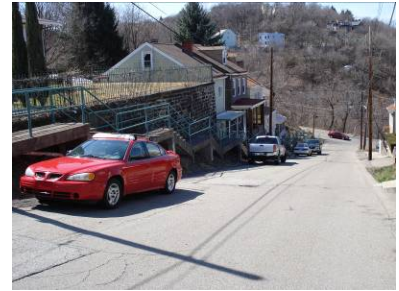
Structural Cracking

Approximately one third of the steps and landings on this staircase exhibit at least one of these structural issues.

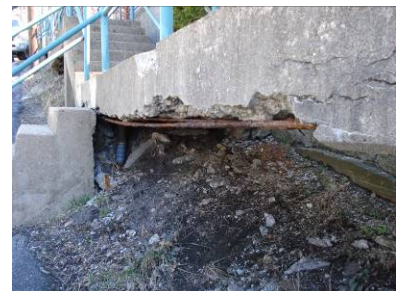
Exposed Steel

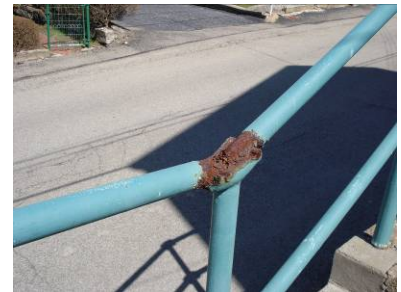
railing joints and rusting at the base of vertical support. In addition to rust damage, one section of railing is missing on this staircase. These railings do not meet IBC.

Rusting Handrail Joint

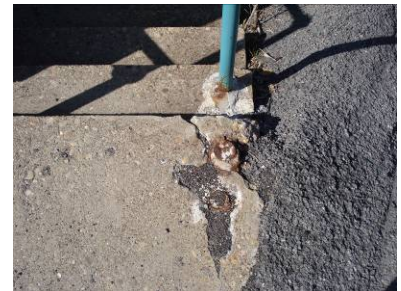
Handrail Rusting

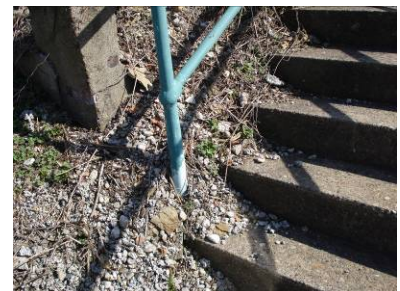
Runoff Debris

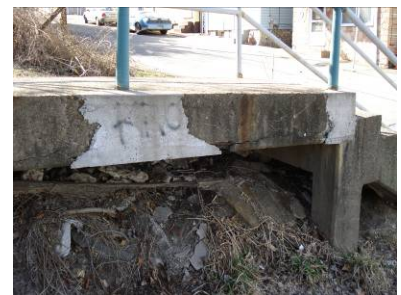
Structural Cracking

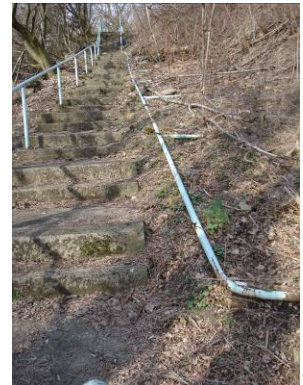
Missing Handrail

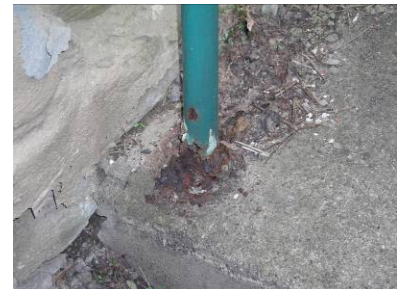
Handrail Rusting

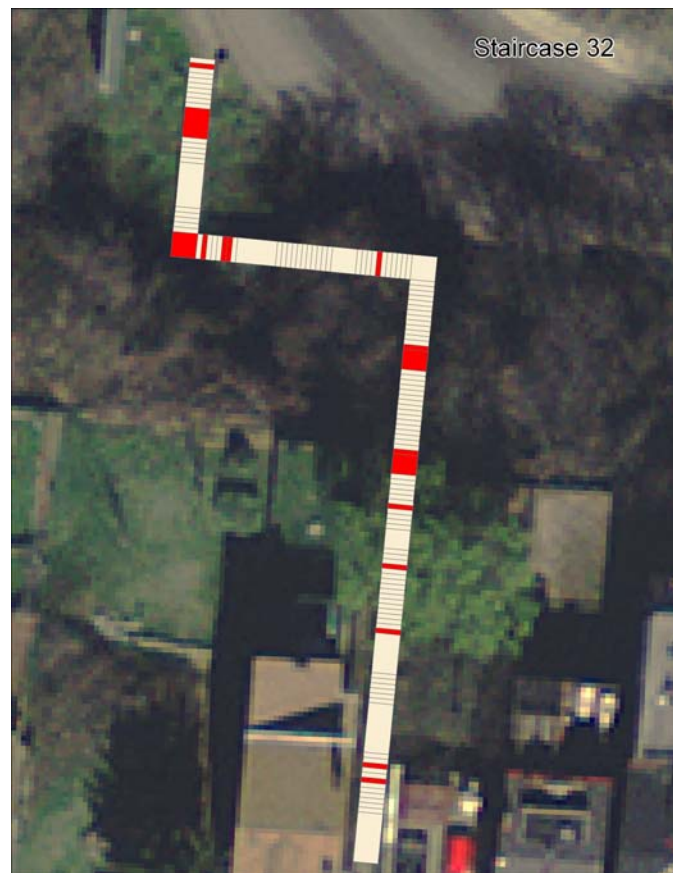
The staircase contains some surface cracking and minor spalling, chipping, exposed steel, and age/wearing. There are twelve step treads that have cracking located throughout the staircase. The figure below shows the location of each of these cracked treads.

Location of surface cracking on Staircase 32.

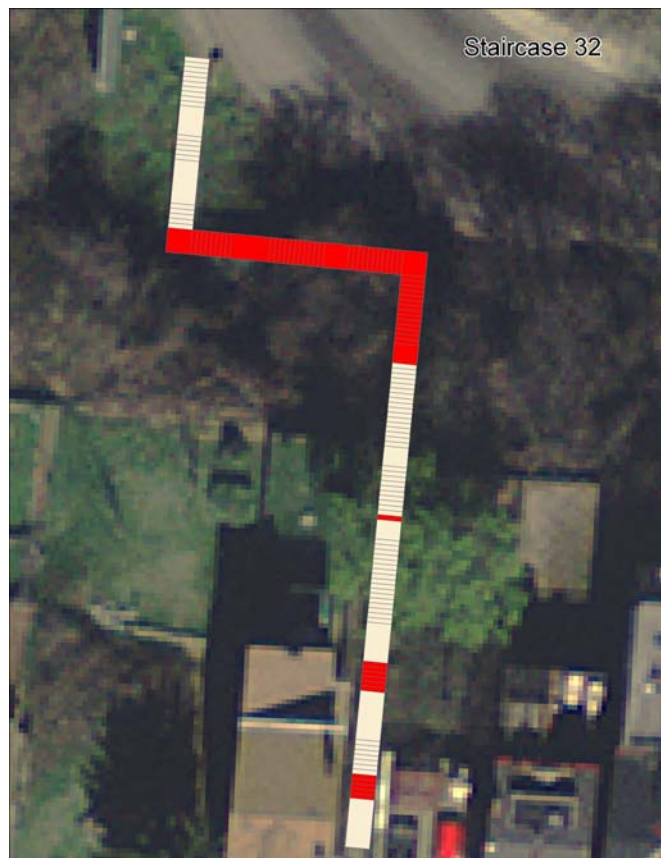
The structure of the staircase is in poor condition. The support columns have cracking, exposed steel, chipping, and rusting. Over fifty percent of the staircase length has structural damage. Structural cracking, chipping and exposed steel are the types of damage that are most prevalent on this staircase. Repair of the support columns particularly in area running parallel to the hillside is a priority. The figure below shows the location of structural exposed steel on this staircase.

Location of structural exposed steel on Staircase 32.

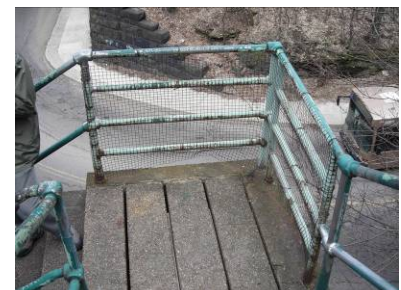
The railings are constructed of metal. They are painted but have rusting throughout the entire staircase. They are in fair condition but do not meet IBC standards. One area of concern is the wire mesh fence on the backside of the handrail over 18th street.

Wire Mesh

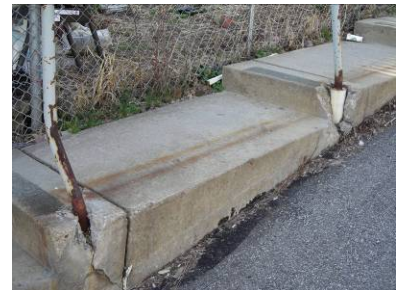
Handrail Damage

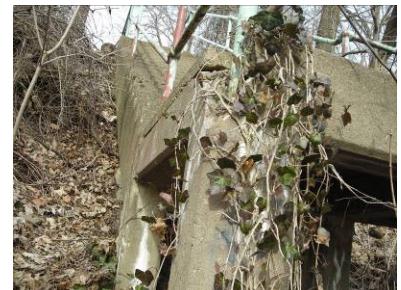
Overgrowth

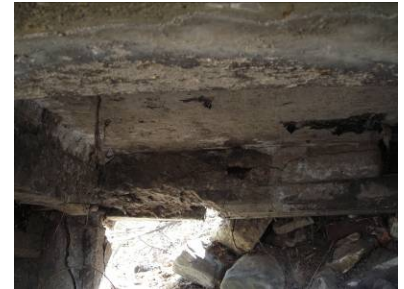
Structural Chipping

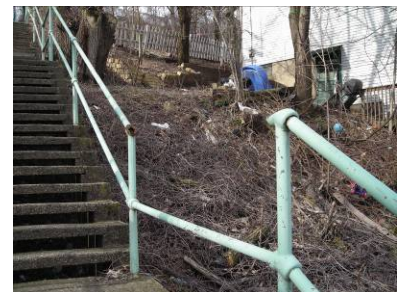
Missing Railing

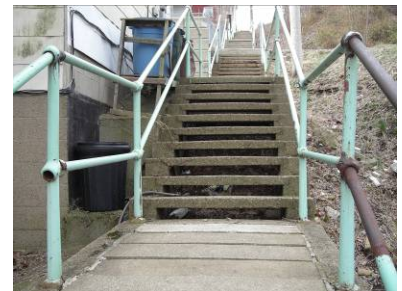
Handrail Rusting

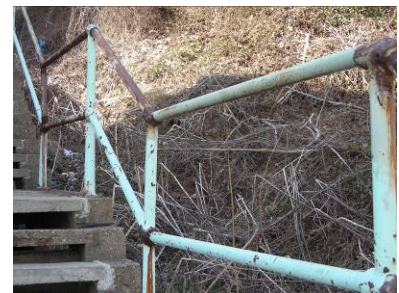
Handrail Rusting

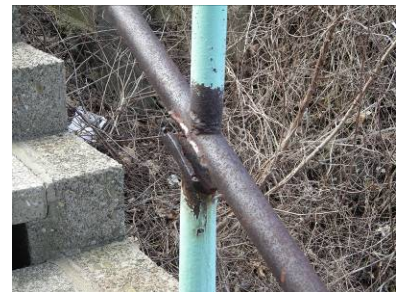
Handrail Rust and Joint Damage
