SOUTH SIDE PARK GREENSPACE MANAGEMENT PLAN

South Side Local Development Company

**SKELLY and LOY, Inc.
Engineers-Consultants
Pittsburgh/Harrisburg, PA**

DECEMBER 2008

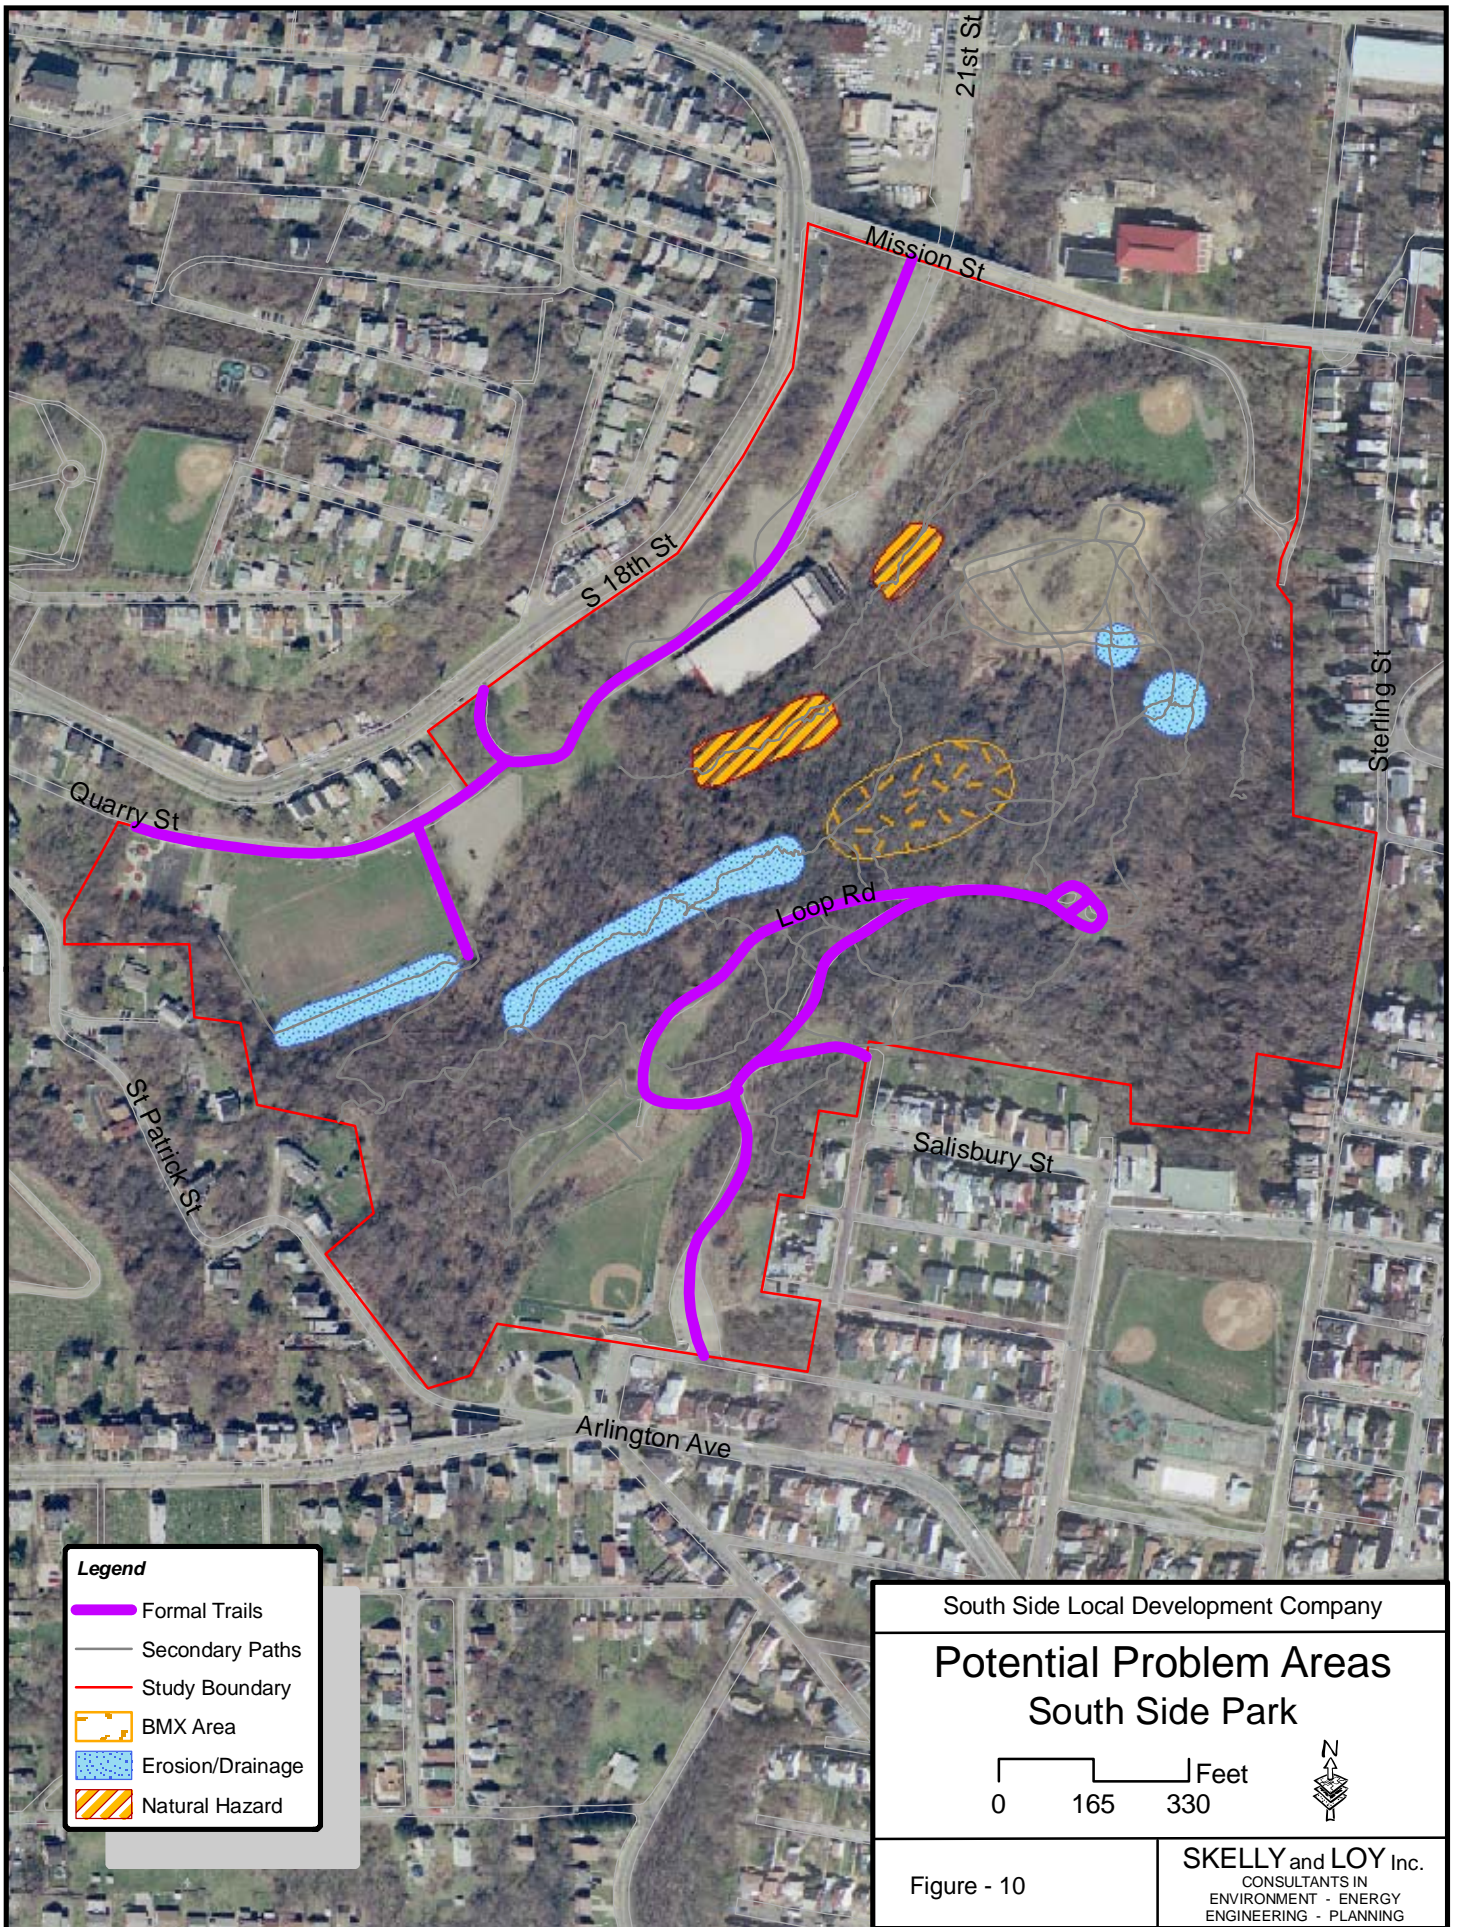
Figure - 10

There are also many specific problem areas on the secondary path system. Chief among them is the path leading from behind the ice rink to the top of the ridge. This path is especially narrow throughout its climb up the steep hill. At some locations, it is very close to the long cliff's edge formed at the top of the sandstone/shale ridge. Although standing at the precipice can create a unique experience and offers an interesting view of the ridge from the top, the cliff's edge is a natural hazard. Unfortunately, this trail is one of the quickest ways to get to the upper half of the park from either 18th Street or the Flats. This location and other problem trail areas are shown on Figure 10.

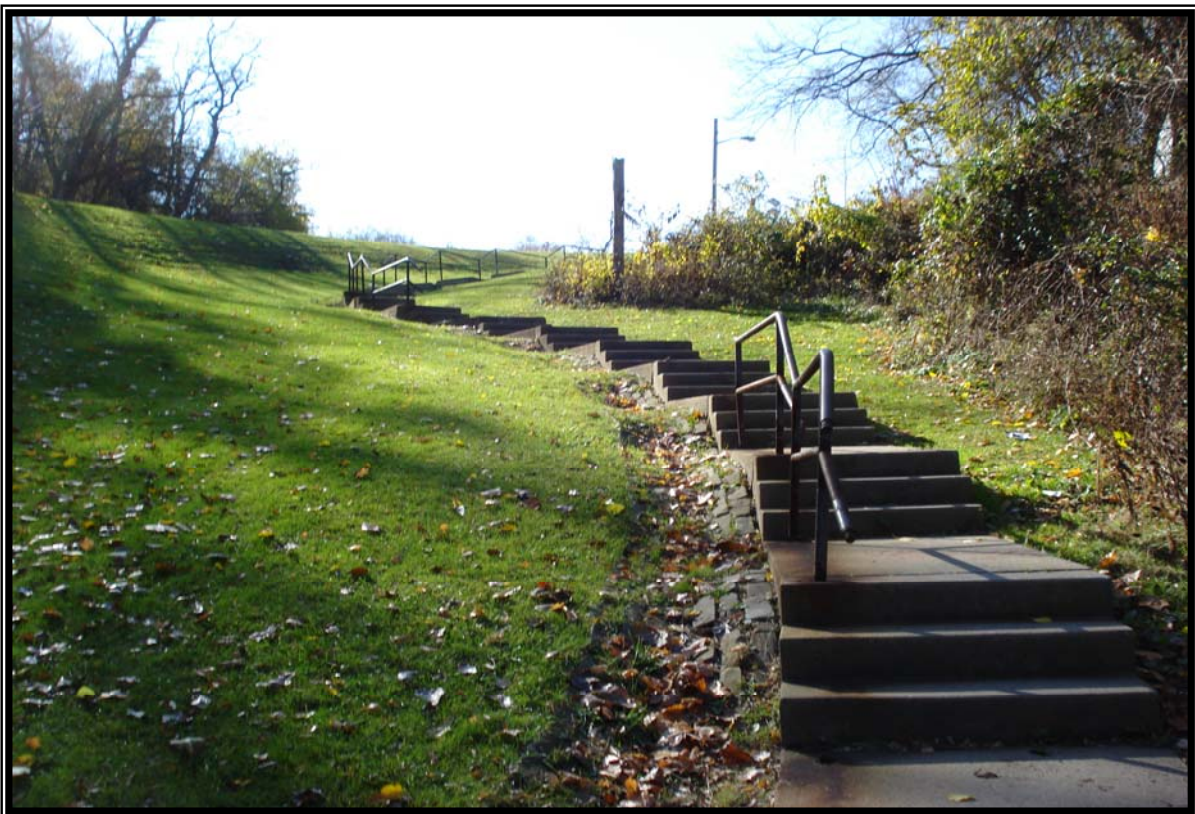
Photograph 8

Overall, the condition of this trail is poor. The pavement is deteriorating and ill-defined; sidewalks are cracked; large chunks of concrete have separated on the steps, exposing reinforcing bars; large sections of the railing on the steps are missing; and litter is evident everywhere. The steps are shown in Photo 8.

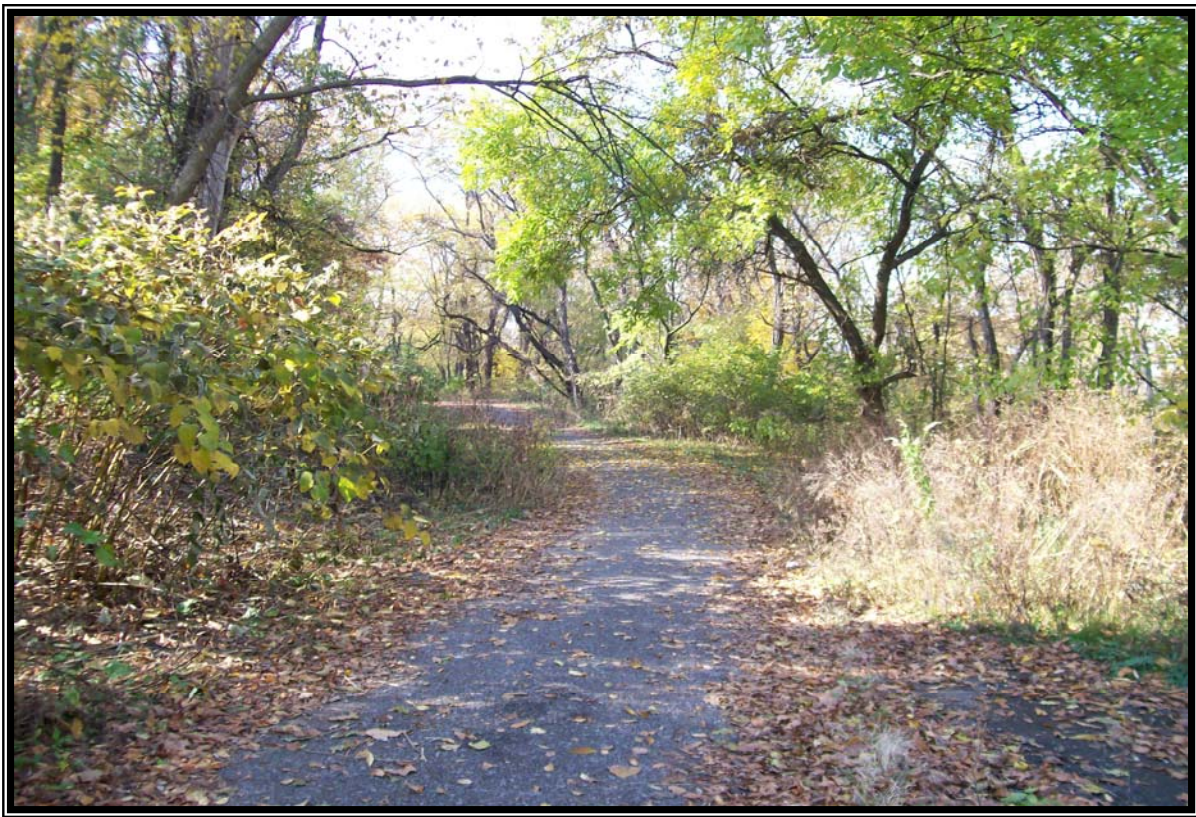
Photograph 9

The condition of this trail is very good, but its use for vehicular traffic, even to a limited extent, detracts from the park experience. The scale of this trail may be too wide for the park and it could function better with a narrower width. Photo 9 shows a section of this trail.

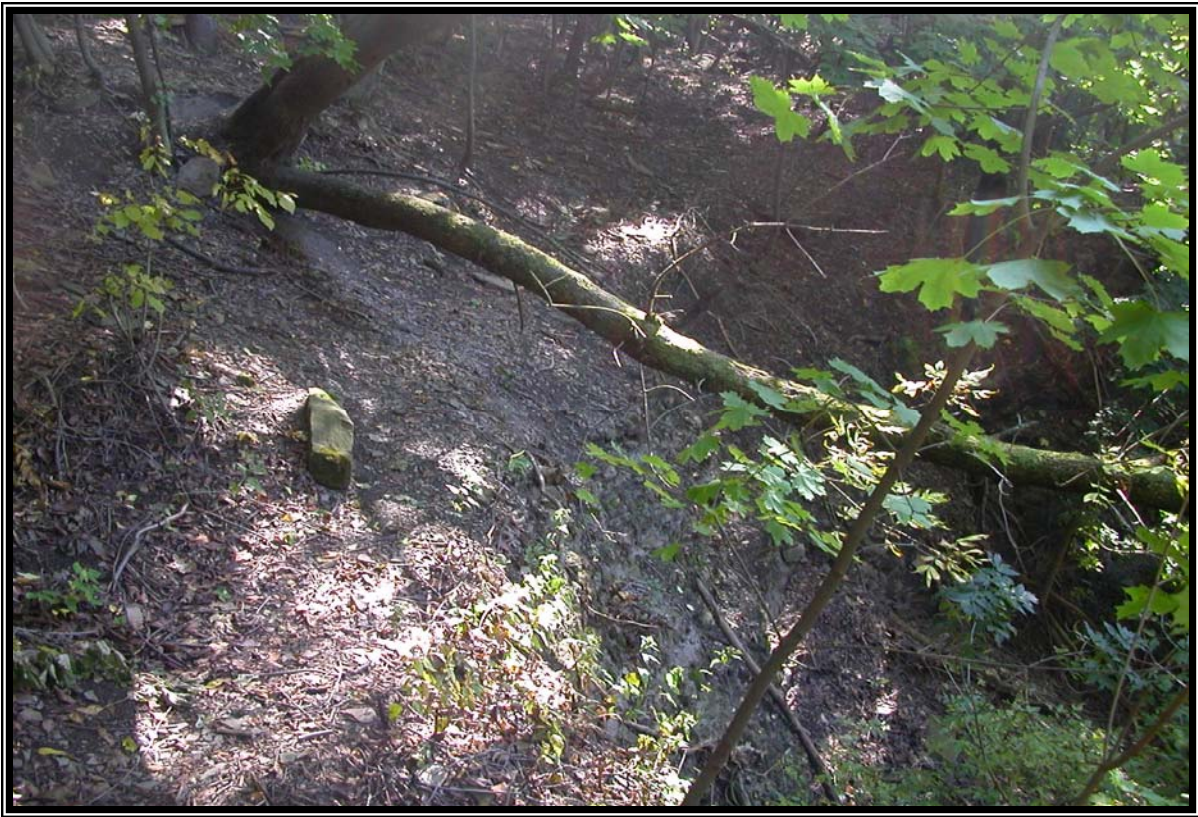
Photograph 11

A similar problem exists on a nearby parallel trail running from the north end of the skating rink's old parking lot to an area midway behind the parking lot. The problem is compounded here because the trail climbs the hill and dead-ends over loose, slippery sandstone. Photo 11 shows this area.

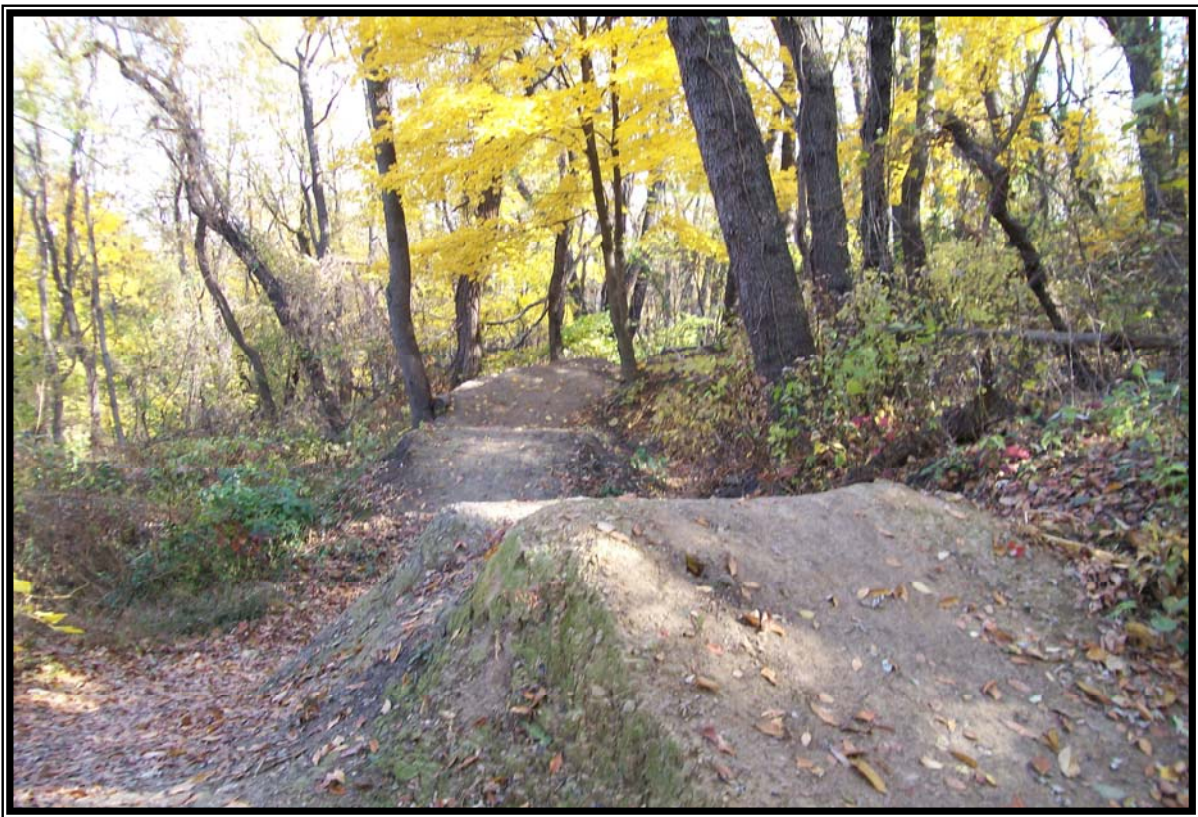
Photograph 12

It is important to note, however, that in one location, in the north central part of the park, an unapproved BMX trail has been constructed illegally. Although the BMX trail is an interesting place, it was not built with city permission, and because its construction dates back many years, no one knows who built it. Not only has the BMX trail caused soil erosion and drainage problems, it may be exposing the city to liability problems.

Many residents think the BMX trail is no longer in use, but that is not the case. New bicycle tire tracks have been observed on some of the more than dozen hill obstacles. Hand tools, such as shovels, spades, and a rake, have also been found hidden under a downed tree. The southern entrance path has been recently graded and three smaller humps recently built. Someone is obviously expanding the track, even as nearby residents believe its heyday is over. The continued use of the BMX trail offers a challenge to the park. Photo 12 shows a very small portion of the BMX track.
