SOUTH SIDE SLOPES

Public Staircase Inspection

Baker

July 2008

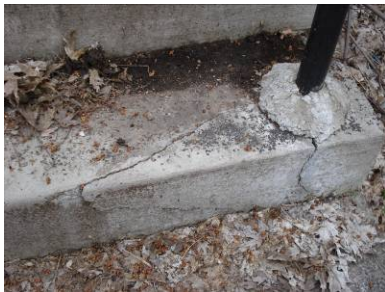
Surface Cracking at Handrail Base

The first section of the staircase has mild spalling and rust staining from the surrounding COR-TEN steel structure. The second section of the staircase also contains rust staining on the surface of the bridge from both the COR-TEN steel structure and the chain link fence surrounding the bridge. The third section of the staircase contains some cracking, mainly on the surface of the steps at the base of the handrail.

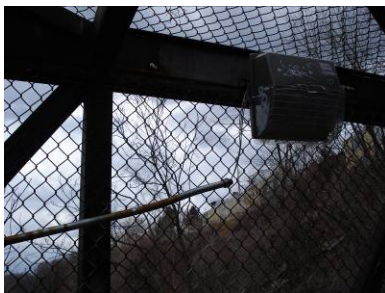
Inoperable Light

The lighting on the first section of the staircase is sufficient. Lighting in this section consists of one light on each landing; this configuration provides enough light to illuminate the stairs above and below the landing. The second section of the staircase has sufficient lighting installed, but the southern most light is not operational. Repairs to this light will provide adequate lighting for this section. The third section of the staircase contains sufficient lighting at both the bottom and top of the section, but lighting in the

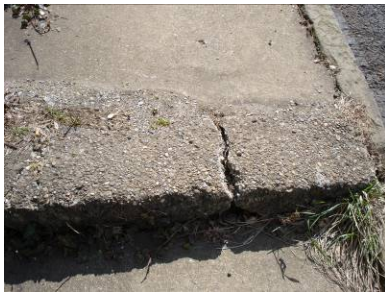
This staircase contains a significant amount of cracking and spalling throughout the staircase.

Surface Cracking

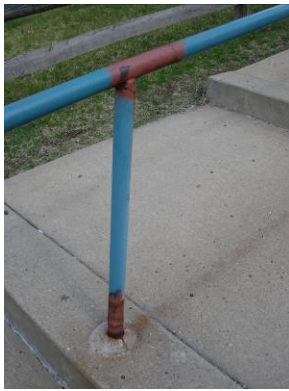
Rusting Handrail

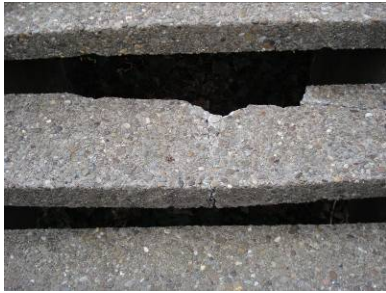
This staircase exhibits a significant amount of cracking (including cracking at the base of handrails) and to a lesser extent spalling and wear due to aging throughout the staircase. In addition to these surface defects, on nineteen (19) steps portions of the concrete has eroded or chipped away exposing the rebar and four steps were noted to be loose.

Surface Chipping

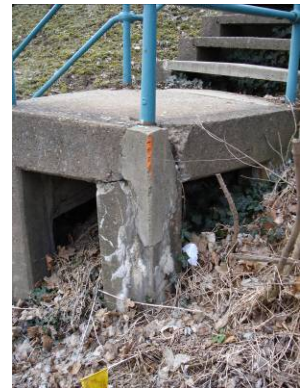
Structural Chipping

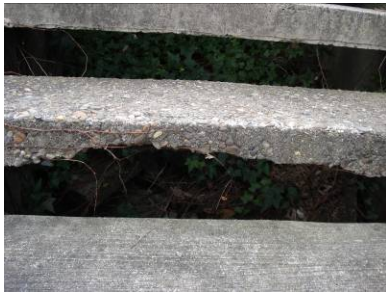
Surface Chipping

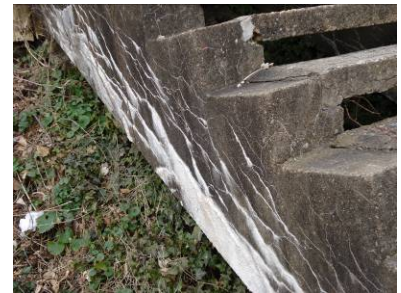
Efflorescence

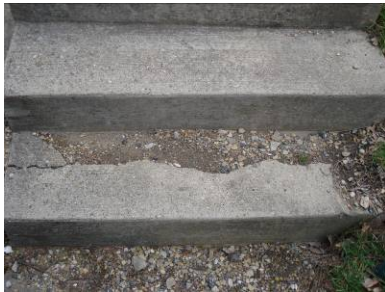
Spalling

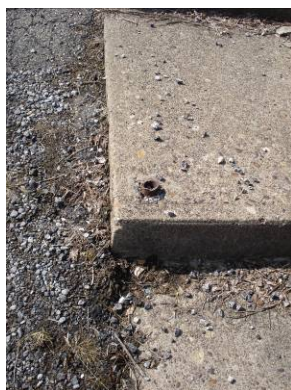
Missing Handrail

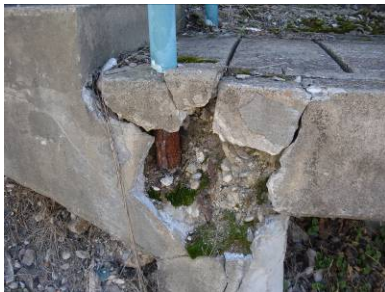
Structural Cracking

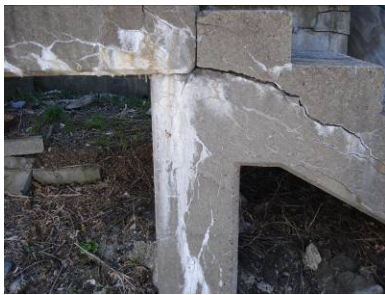
Structural Cracking

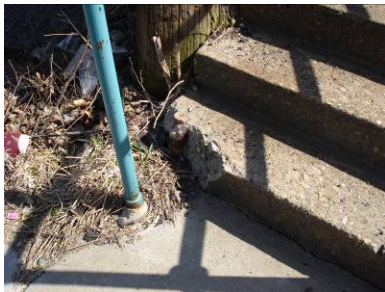
Surface Chipping

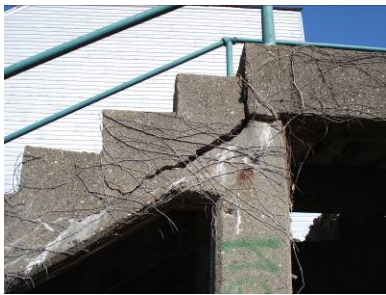
Structural Cracking

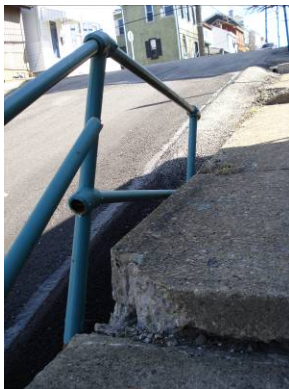
Damaged Handrail

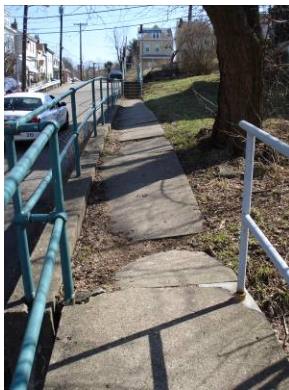
Excessive Slope

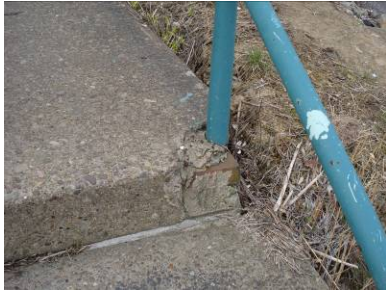
Surface Chipping

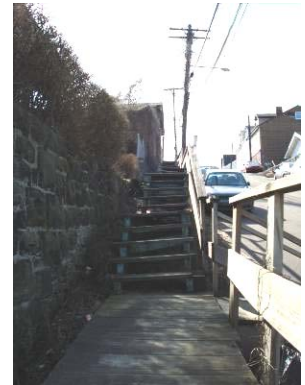
Staircase Twenty-Three

The wood boards that make up the stairs are extremely aged and worn. Some of the steps are broken.

The wood elevated structure of the steps is uneven and not sturdy. The nails used to keep the structure together are raised. The wood is cracked, rotted, and has holes in multiple places.

This staircase was not in the scope of this project but was adjacent to project staircases. The condition of this staircase is poor and a full demolition and replacement with concrete steps is recommended for a long-term solution. A repair cost estimate was not developed for this staircase.

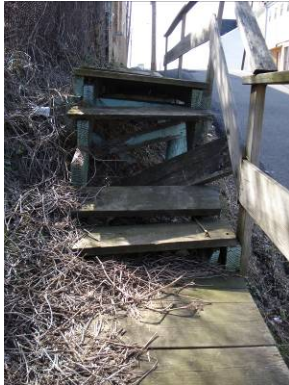
Rotten Steps

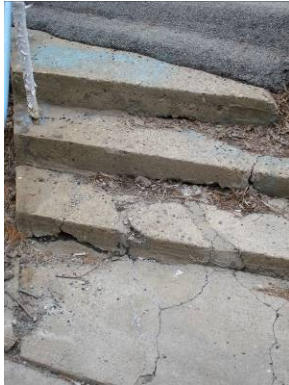
The surface has major cracking and chipping, and concrete slabs have settled causing expansion joints to open and creating an excessive slope perpendicular to the pedestrian traffic.

Surface Cracking

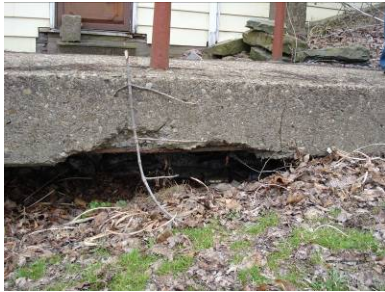
Structural Exposed Steel

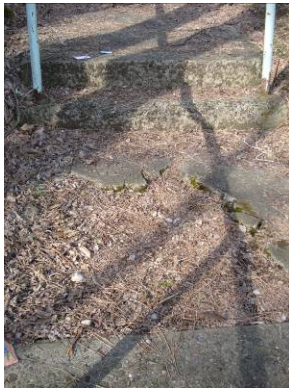
The staircase contains major chipping and cracking on the surface and at the base of the handrails, as well as some exposed steel, spalling, and rusting.

Eroded Step

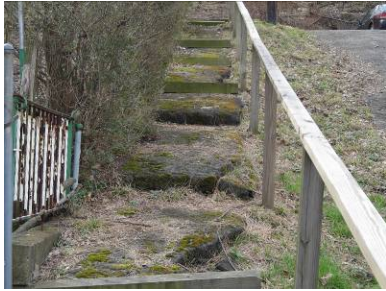
The staircase contains major cracking, chipping, and spalling. The slopes of the landings fail IBC standards. The top half of the staircase is moss covered and slippery.

Moss Covered Steps

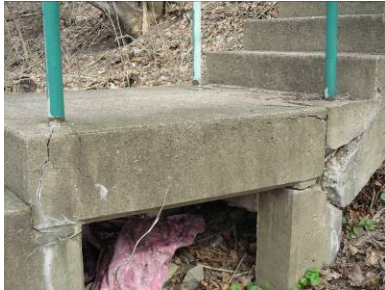
Structural Cracking

The staircase has major structural cracking, chipping, spalling, exposed steel, and rusting. The majority of these areas can be found at or near the landings.

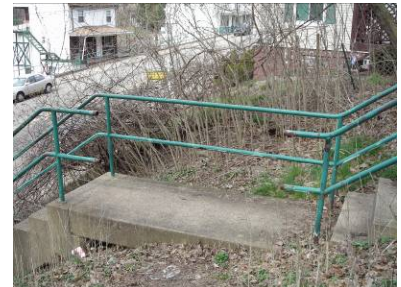
The railings are constructed of metal. They are painted but have rusting through out the entire staircase and are unstable/missing in numerous areas. They do not meet IBC standards.

Missing Handrail

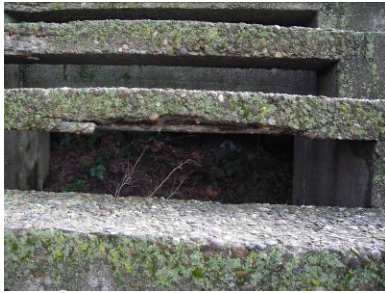
Exposed Steel

The structure of the staircase has cracking, exposed steel, and chipping. All of the structural cracking can be found on the landings.

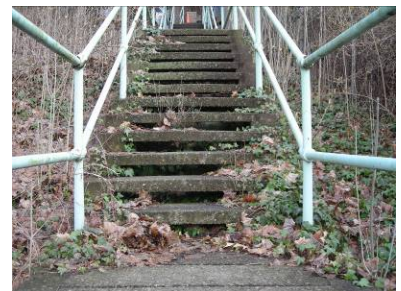
Overgrowth

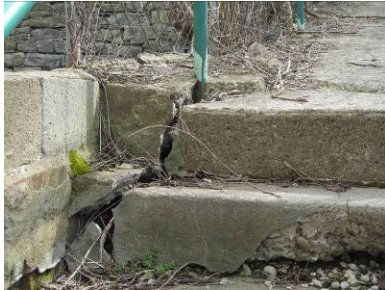
Surface Cracking

The staircase has chipping, spalling, age/wearing, and major cracking on the surface and at the base of the handrails. One step near the top of the stairs is missing large pieces and is almost gone. The slopes of the landings also fail IBC standards.

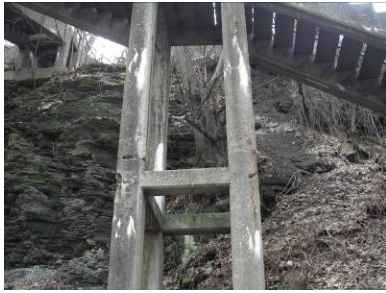
Structural Chipping and Efflorescence

The structure of the staircase is in poor condition. The support columns have cracking, exposed steel, chipping, and rusting. Over fifty percent of the staircase length has structural damage. Structural cracking, chipping and exposed steel are the types of damage that are most prevalent on this staircase. Repair of the support columns particularly in area running parallel to the hillside is a priority. The figure below shows the location of structural exposed steel on this staircase.

STRUCTURAL CONCRETE REPAIR - First, all loose and delaminated concrete is removed, especially around corroding reinforcing steel. At all edges of a patch, right angle saw cuts to the concrete surface are provided to terminate the patch against. Abrasive blasting then removes bond inhibiting materials such as dirt or loosely bonded aggregates. All heavy corrosion and scale must also be removed from the reinforcing steel. If the reinforcing steel has lost a significant amount of its cross section a structural engineer must be consulted to provide more detailed analysis and recommendations.

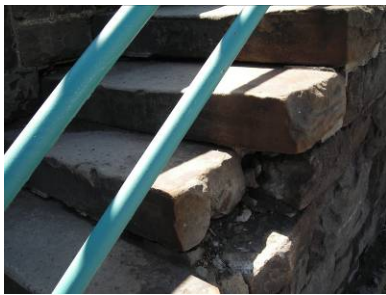
The staircase has some cracking, chipping, age/wearing, and loose steps.

Surface Chipping

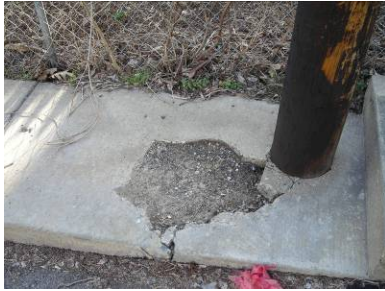
Surface Spalling

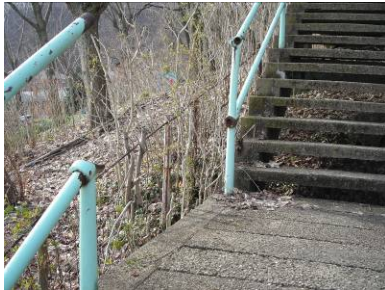
Missing Handrail

The railings are constructed of metal. They are painted but have rusting through out the entire staircase and are bent in numerous areas. There is a missing hand rail on one side of the landing. They do not meet IBC standards.

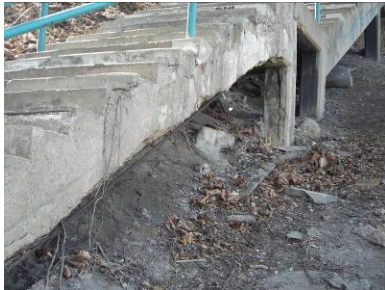
Structural Exposed Steel

The staircase has major structural cracking, chipping and exposed steel. The majority of these areas are in the foundation of the landings. One of the landings has addition wood support in the foundation.

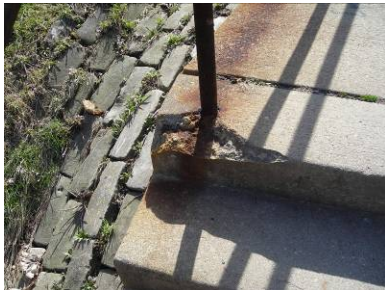
Handrail Rust and Surface Chipping

The staircase has major surface cracking and chipping, as well as a number of instances of spalling, rusting, exposed steel, and cracks at the base of the hand rails. The slopes of a majority of the landings also fail IBC standards.

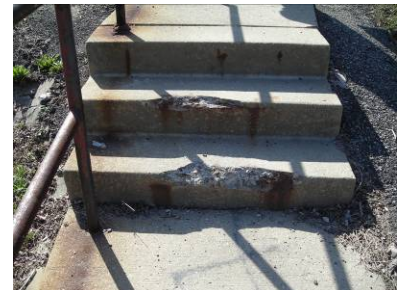
Surface Chipping

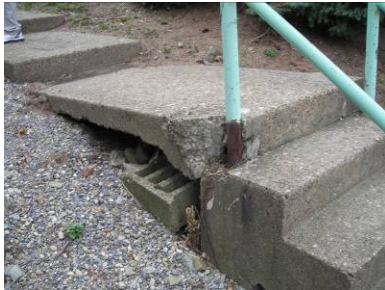
Chipping at Handrail Base

The surface has some exposed steel, chipping, minor surface cracks and cracks at the base of the handrail. The slopes of all but one landing fail IBC standards.

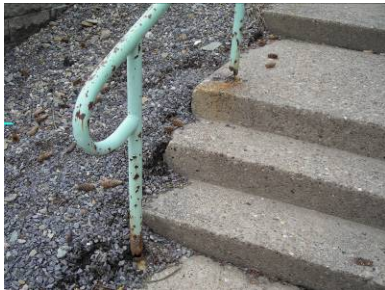
The railings are constructed of metal. They are painted but have rusting through out the entire staircase. The railings are rusting out at the base and are unstable. The middle section of the staircase is missing the handrail on one side. They do not meet IBC standards.

Handrail Rusting

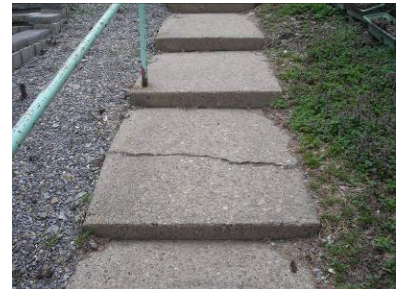
Surface Cracking

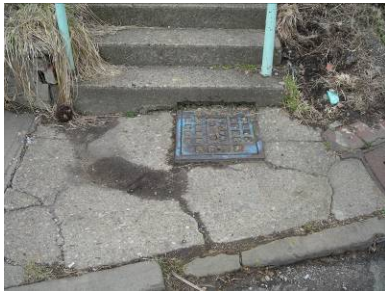
Surface Cracking

The surface has some cracking, spalling, exposed steel, and chipping.

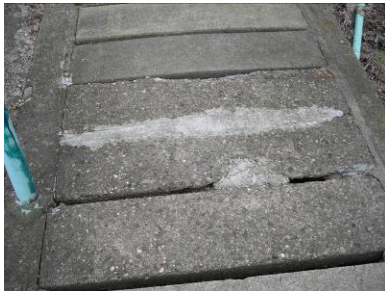
Surface Cracking

The surface has some cracking, spalling, exposed steel, chipping, and loose steps.

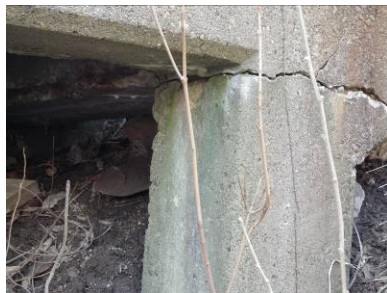
Structural Cracking

The staircase has some structural cracking, exposed steel, rusting, chipping, and spalling.

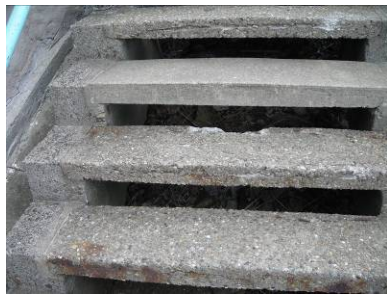
Surface Cracking

The surface has numerous instances of cracking, chipping, loose steps, and a few occurrences of exposed steel and rusting.
